It is intended to offer this paper to the NACE Corrosion 2010 Conference

IRON-OXIDIZING BACTERIA: A REVIEW OF CORROSION MECHANISMS IN FRESH WATER AND MARINE ENVIRONMENTS

Richard I. Ray*, Jason S. Lee*, Brenda J. Little**
Naval Research Laboratory
Codes 7332*/7303**
Stennis Space Center, MS 39529

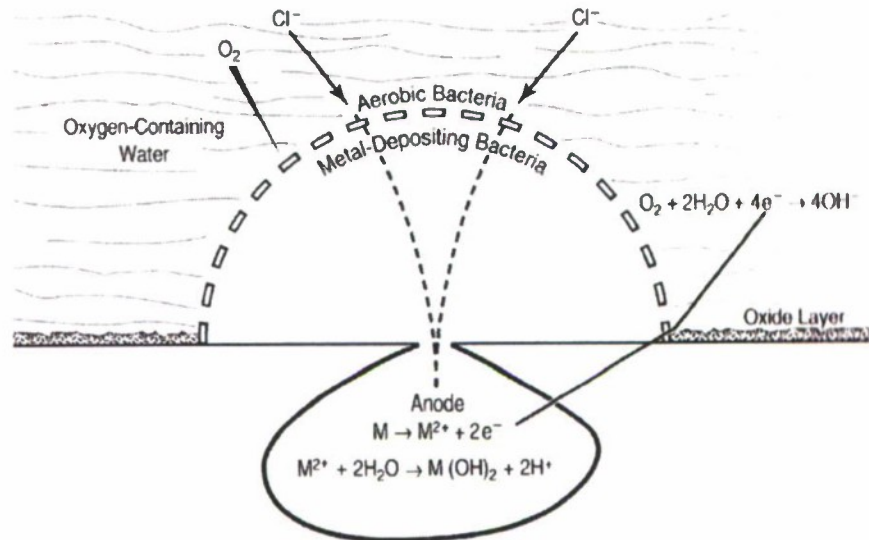
Figure 1. Possible reactions under tubercles created by metal depositing bacteria.

The IOB that have received the most attention in MIC are *Gallionella*, *Leptothrix*, and *Siderocapsa*. Most of the documented case histories MIC associated with IOB have involved exposure of a 304 or 316 stainless steel to well water or chlorinated drinking water. The corrosion mechanism is under-deposit corrosion or formation of a differential aeration cell.⁷⁻¹⁵ Under stagnant conditions, IOB form dense deposits within months, excluding oxygen from the area immediately under the deposit and initiating a series of events that are individually or collectively very corrosive (Figure 1). In an oxygenated environment, the area deprived of oxygen becomes a relatively small anode compared to the large surrounding oxygenated cathode. Metal at the anode dissolves, forming metal cations that undergo hydrolysis and decrease pH. The extent of the pH decrease is determined by the alloy composition.¹⁶ For this reason, underdeposit attack is particularly aggressive on 300 series stainless steels, containing 17.5 to 20% Cr. In addition, chloride (Cl^-) from the electrolyte migrates to the anode to neutralize any buildup of charge, forming metal chlorides that are extremely corrosive. Under these circumstances, pitting involves the conventional features of differential aeration, a large cathode:anode surface area and the development of acidity and metallic chlorides.

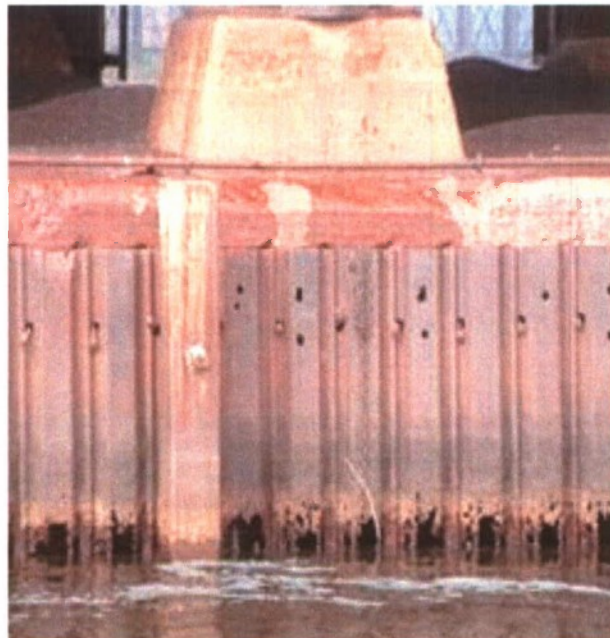
Figure 2. DSH piling with visible perforation at the water line.*

In a study to determine the cause of aggressive localized corrosion on carbon steel pilings in Duluth-Superior Harbor, MN and WI, (DSH), Hicks,¹⁷ using the gradient technique described by Emerson and Moyer,⁴ isolated an IOB from corroded areas on coupons. He identified the organism as *Sideroxydans lithotrophicus* by sequencing the 16S rDNA. The corroded carbon steel (CS) pilings have an orange rusty appearance (Figure 2). Divers reported that tubercles were randomly distributed from the waterline to approximately 3 m below the surface, an area influenced by ice scouring.^{18,19} Tubercles varied in diameter from a few millimeters to several centimeters and when removed, large and often deep pits were exposed (Figure 3a&b). Ray et al.²⁰ examined tubercles formed in DSH in detail. X-ray diffraction data indicated that tubercles were amorphous Fe oxides surrounded by magnetite (Fe_3O_4). Transmission electron microscopy (TEM) confirmed amorphous Fe oxides in association with bacteria (Figure 4). Tubercles were made up of porous layers or strata (Figure 5). Diatoms, animals with siliceous frustules, colonized the topsides of the tubercles, and an energy dispersive x-ray spectroscopy (EDS) spectrum analysis of the topside indicated the presence of Mg, Al, Si, S, K, Ca and Mn in addition to Fe. The underside of the tubercle, the surface that had been in contact with the metal, was comprised of bacteria with two predominant morphologies: large rod-shaped bacteria (Figure 6a) and long Fe-encrusted filaments (Figure 6b) as identified by environmental scanning electron microscopy (ESEM). Twisted filaments found in the DSH tubercles are typical of sheath-producing microaerophilic IOB, e.g., *Gallionella*. The bacterium is a kidney-shaped cell (not evident in Figure 6b) with an elongated stalk made up of helically wound mineralized fibrils. The underside of the tubercle contained elevated concentrations of S, Sn, Cr and Cu compared to the exterior. Cu was localized at the base of the tubercles and was evident as a greenish sheen on the underside of a tubercle (Figure 7). Gerke et al.²¹

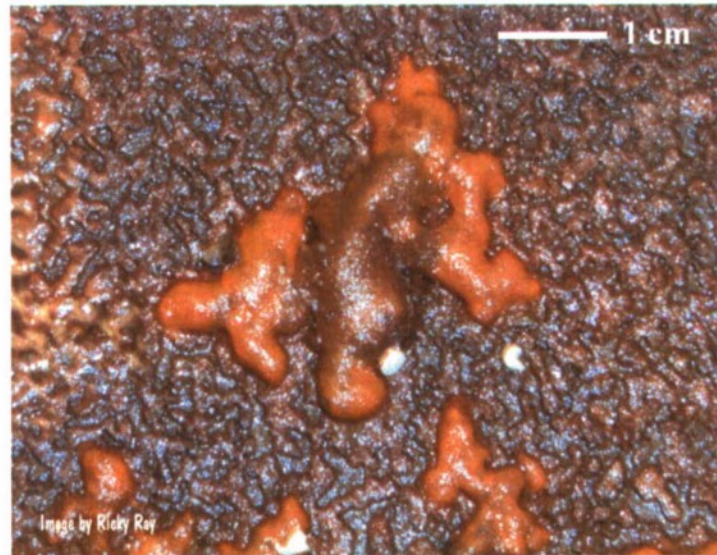
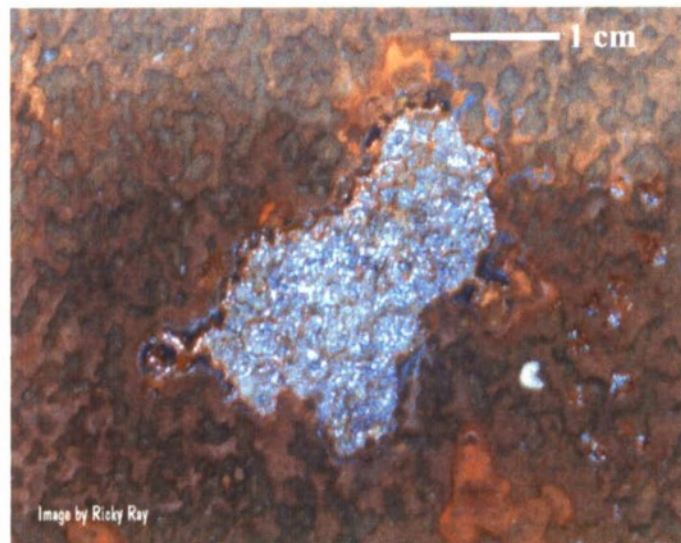
Figure 3a&b. a) Image of tubercle on CS surface and b) after physical removal of tubercle exposing pits underneath the tubercle.

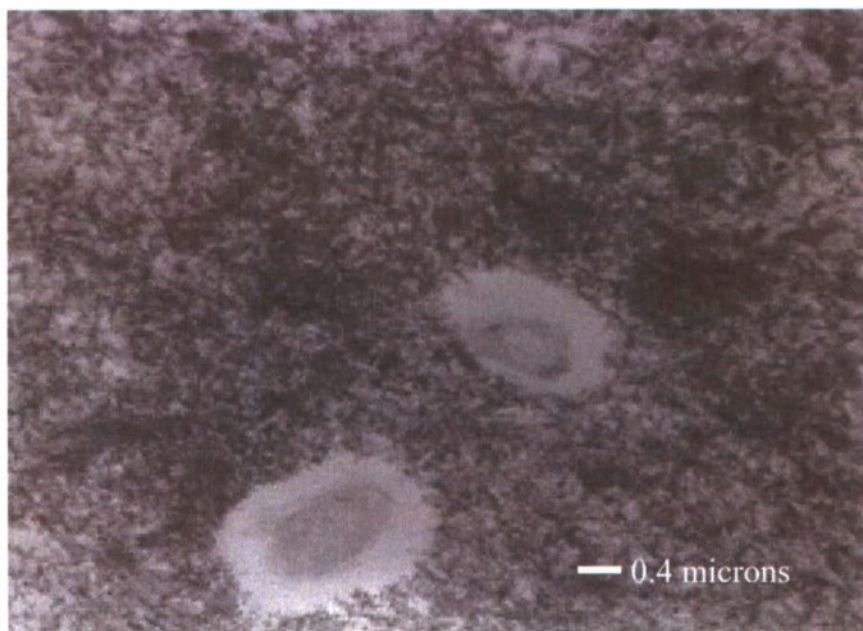
Figure 4. TEM micrograph of tubercle interior in cross-section, showing two bacteria (1.2 micron diameter) surrounded with amorphous iron oxides.

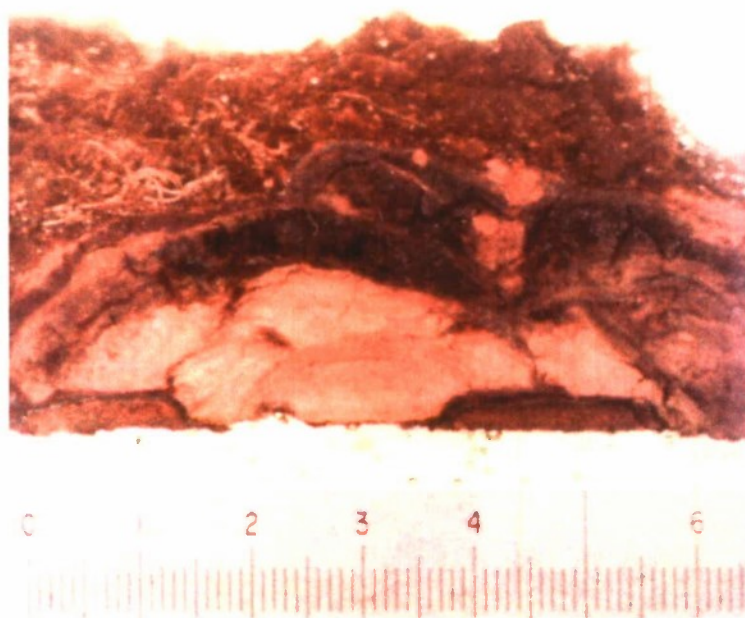
Figure 5. Cross-section of resin-embedded DSH tubercle, showing layers of material within the core. The scale bar indicates 0 – 6 cm.

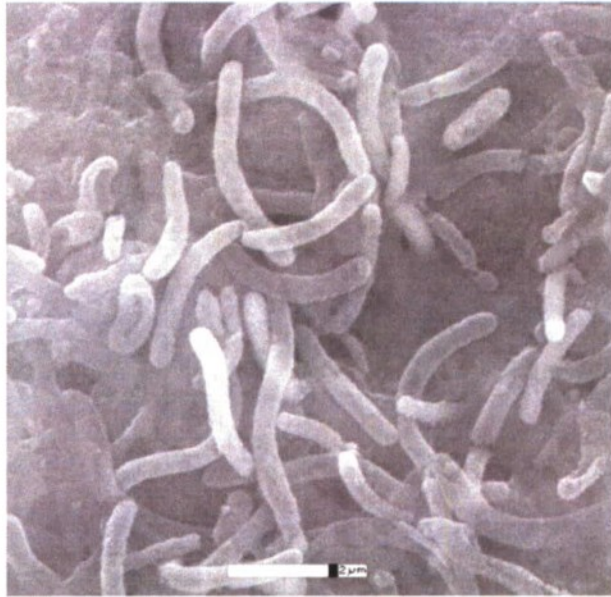
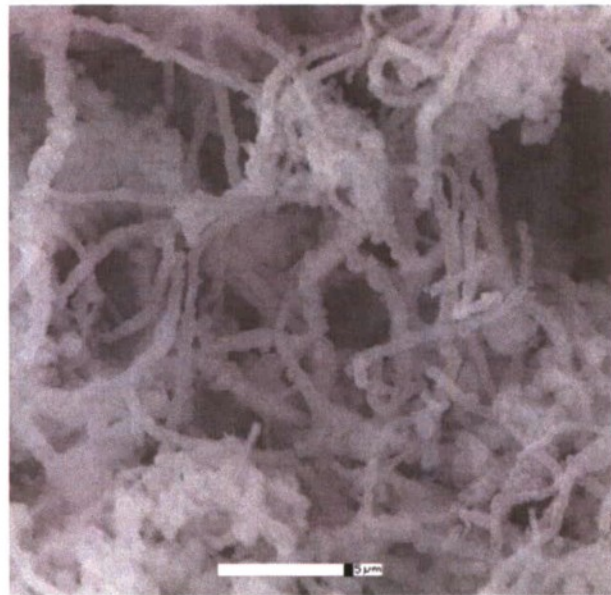
Figure 6a&b. ESEM micrographs from the underside of a tubercle indicating the presence of (a) large rod-shaped bacteria and (b) long iron-encrusted filaments.

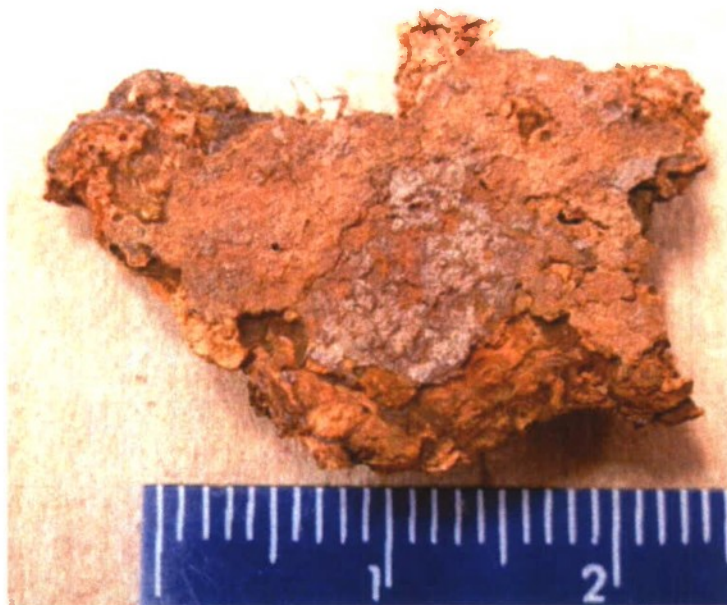
Figure 7. Planar view of the underside of a tubercle. Green sheen is due to accumulation of Cu.

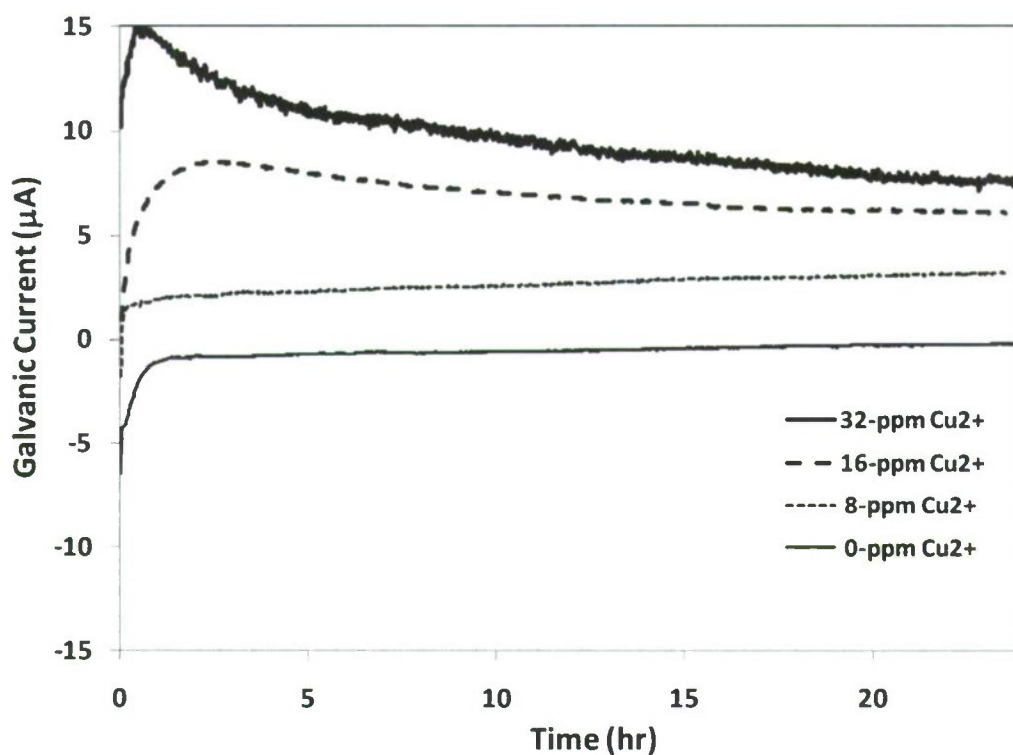
Figure 8. Galvanic current (μA) measured for 24 hr for 1 cm^2 CS coupon in deaerated solutions with 20 ppm Cl^- and different $[\text{Cu}^{2+}]$ coupled to 100 cm^2 CS coupon exposed to the same solution under aerated conditions.

In the Ray et al.²⁰ experiments the magnitude of the galvanic current was related to the amount of copper deposited on the surface, which was directly related to the concentration of dissolved Cu²⁺. Cu²⁺ precipitated on anaerobic CS surfaces. A positive current established by the galvanic couple between the Cu-coated CS (anaerobic anode) and the larger CS (aerobic cathode) was initially high, but stabilized within a few hours (Figure 8). The positive value of the galvanic current indicated that the anode was

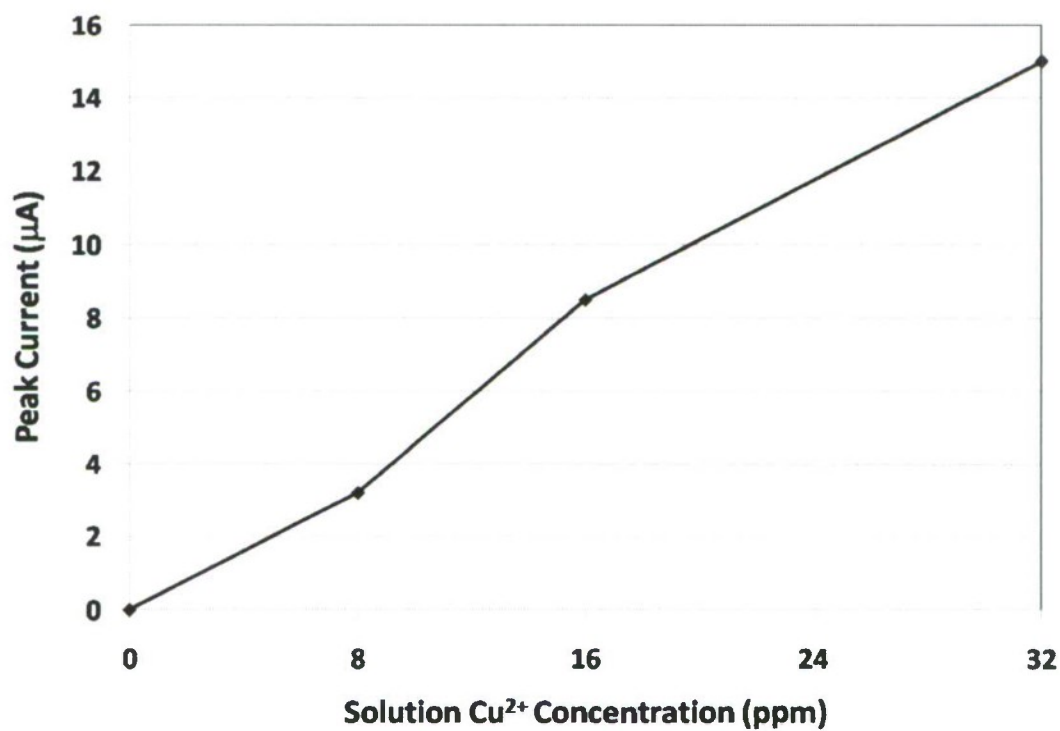
Figure 9. Peak galvanic current (μA) measured during the first 24 hr of exposure under deaerated conditions (for 1 cm^2 coupon) vs. the $[\text{Cu}^{2+}]$ in solution.

preferentially corroding with respect to the cathode. Peak positive galvanic current scaled linearly with solution $[\text{Cu}^{2+}]$ (Figure 9) and can be explained by increased anodic kinetics for Cu-coated CS under anaerobic conditions (Figure 10). When O_2 was introduced to the anaerobic anode, the galvanic current reversed to negative values for all solutions spiked with Cu^{2+} (Figure 11). With both coupons exposed to O_2 , the Cu-coated CS coupon had a higher corrosion potential than the larger CS coupon due to Cu having a higher redox potential than Fe. However, after 0.5 hr the galvanic current again reversed to positive values indicating that the Cu-coated coupon was again preferentially corroding with respect to the larger CS coupon. Ice scouring breaks tubercles allowing ingress of O_2 and aggressive corrosion. The depth of the aggressive corrosion coincides with the range over which ice scour is reportedly important. The peak galvanic current under both anaerobic and aerobic conditions was related to $[\text{Cu}^{2+}]$ over the range of 0 to 32 ppm (Figures 9 & 12).

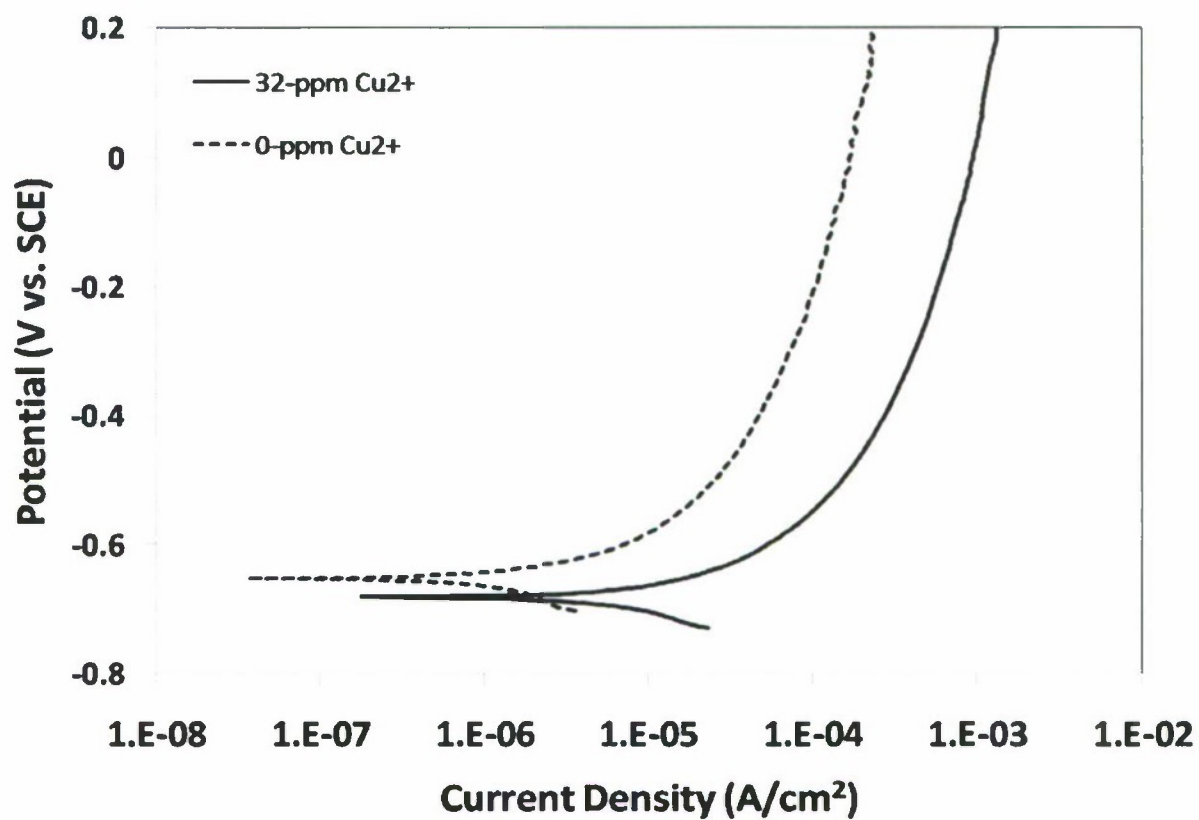
Figure 10. Anodic polarization scans of 1 cm² CS coupons after 24 hr exposure in deaerated solutions of 32 and 0 ppm Cu²⁺ with 20 ppm Cl⁻.

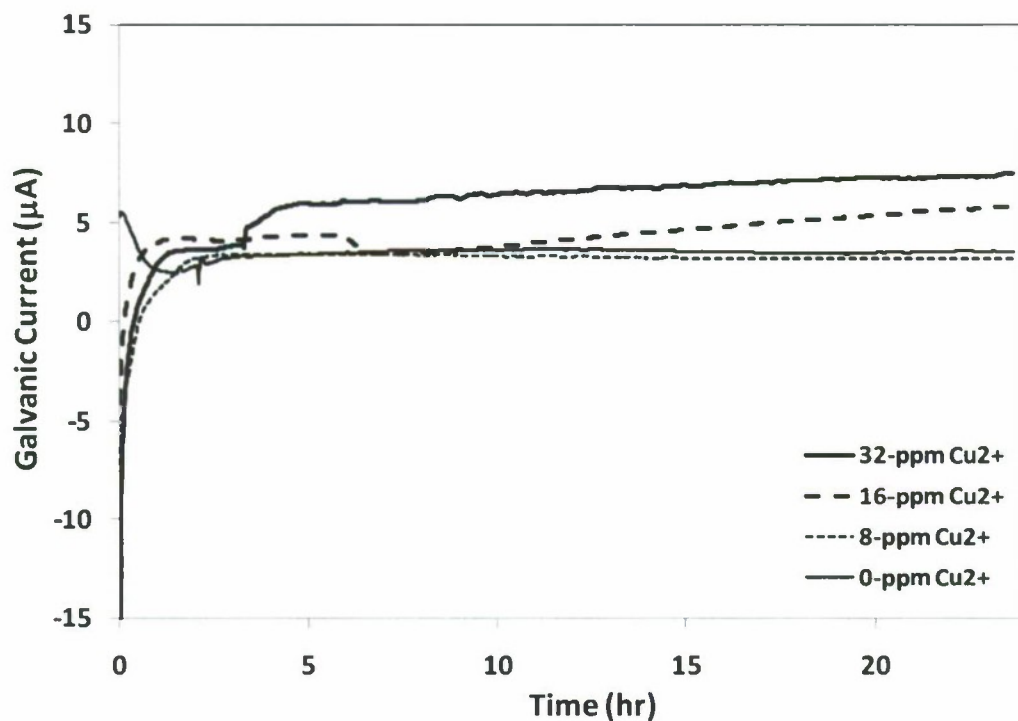
Figure 11. Galvanic current (μA) measured for 24 hr after deaerated solutions (Figure 7) were opened to air.

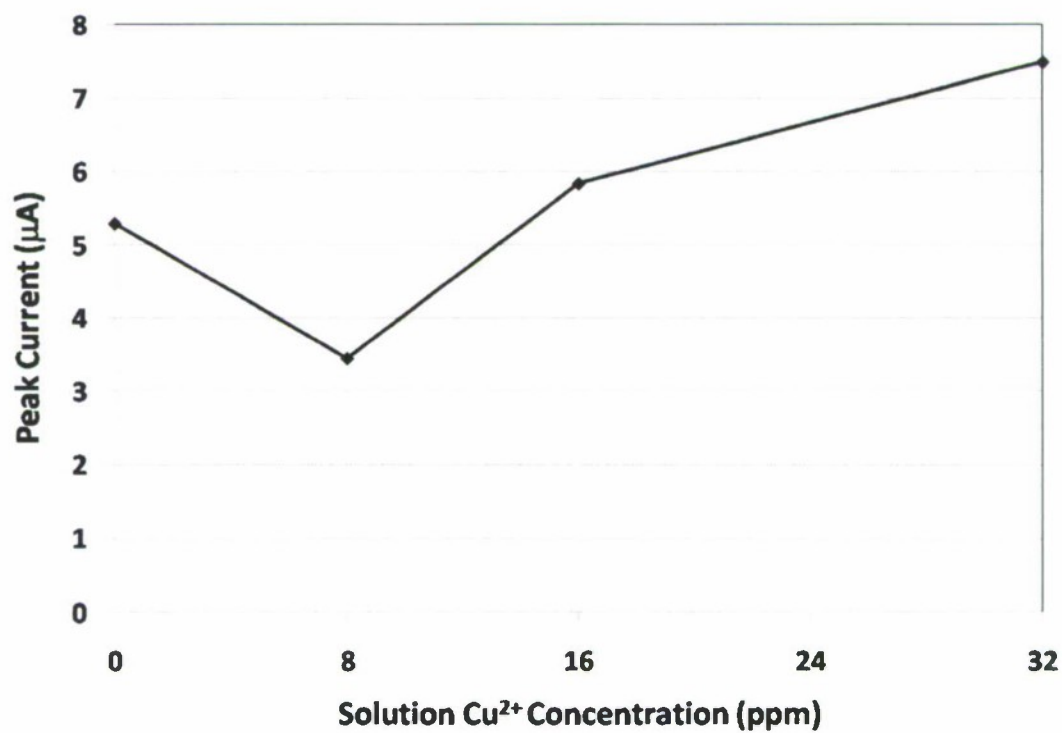
Figure 12. Peak galvanic current (μA) measured during the second 24 hr of exposure under aerated conditions (for 1 cm^2 coupon) vs. the $[\text{Cu}^{2+}]$ in solution.

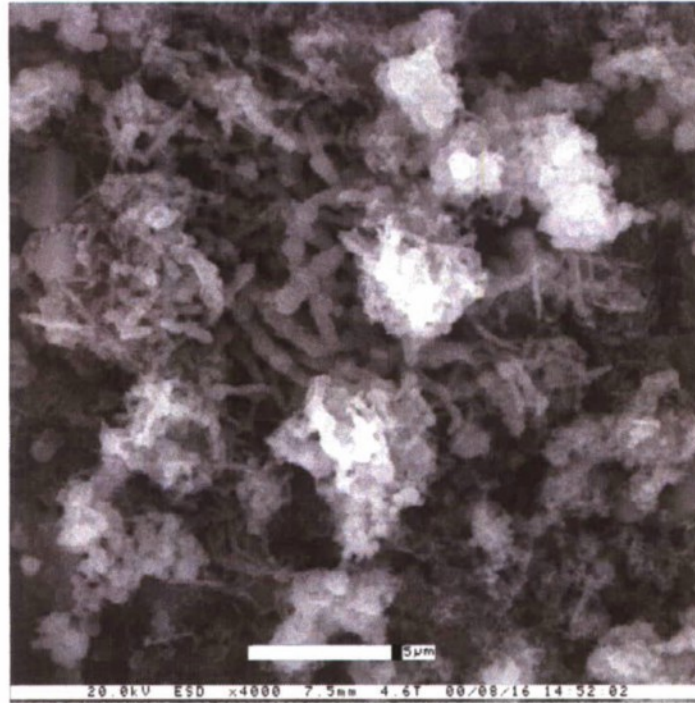
Figure 13. Micrograph of iron-encrusted bacteria associated with tubercles on a corroded weld of 316L stainless steel (UNS S30403) after 10-week exposure to flowing seawater.³⁶

Ray et al.³⁶ demonstrated iron-encrusted bacteria associated with tubercles on a corroded weld of 316L stainless steel (UNS S30403) after 10-week exposure to flowing seawater (Figure 13). The term "rusticle" was coined by Ballard³⁷ to describe rust features covering the wreck of the ocean liner RMS *Titanic*. The wreck has been at a depth of 3,800 m for 95 years at a temperature of 1°C and 6000 psi. He described these features as very fragile reddish brown stalactites of rust hanging down as much as several feet, and speculated this was caused by "iron-eating bacteria".³⁷ Cullimore^{38,39} described rusticles on the *Titanic* as, "a complex of microbial communities within an iron-rich and calcium deficient porous-like home." He proposed a corrosion mechanism whereby IOB "were extracting iron from the steel of the ship and then exporting that iron into the oceanic environment as red dust and yellow colloids." He further observed more rusticle-type growth in 1998 than in 1996. Stoffyn-Egli and Buckley^{40,41} studied the mineralogy and microbiology of rusticles recovered from the *Titanic* and concluded that bacteria caused the precipitation of an outer shell of lepidocrocite ($\gamma\text{-FeO(OH)}$) and that the interior of the rusticle was euhedral goethite ($\alpha\text{-FeO(OH)}$) crystals. In addition to IOB they identified sulfate-reducing bacteria (SRB) as responsible for rusticle formation. They proposed a theoretical mechanism for rusticle formation that included SRB, reducing conditions on a small scale within rust flakes and the co-existence of minerals with different redox potentials. Herdendorf et al.⁴² described similar formations on the wreck of the SS *Central America*, a wooden steamer with iron
